**Re: George Collins and
Alrika Collins,
Plaintiffs,**

**State Farm Fire and
Casualty Company,
Defendant.**

**United States District Court for
the Eastern District of Oklahoma
Case #: 22-CV-00318-RAW-JAR**

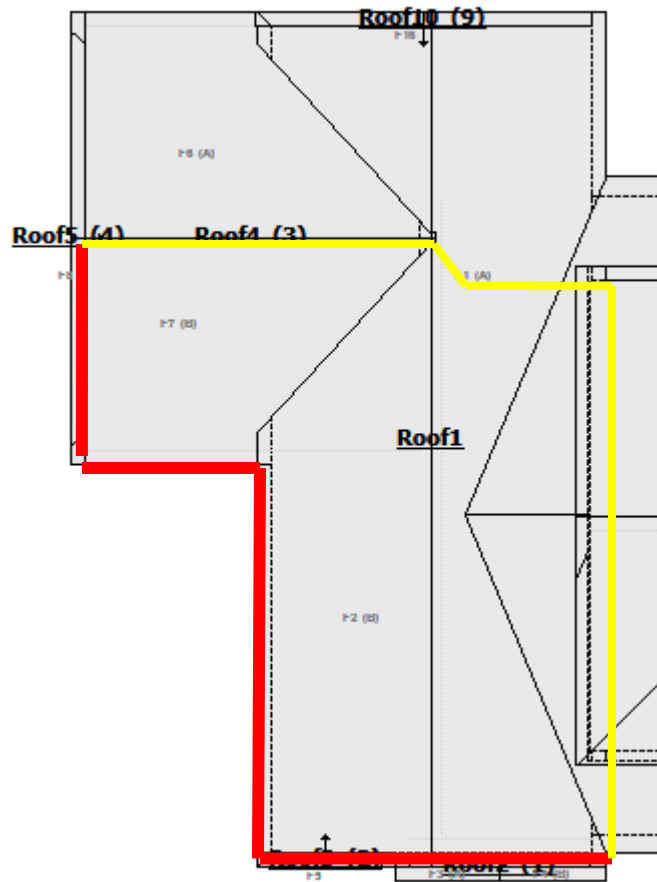
3. The follow diagram of the roof line identifies the locations within the roof's framing the fire damage was largely contained. The yellow lines represent the locations where stud wall (covered with sheetrock) and roof framing members aided in containing the fire and preventing the fire spreading to other sections of the roof and attic framing.

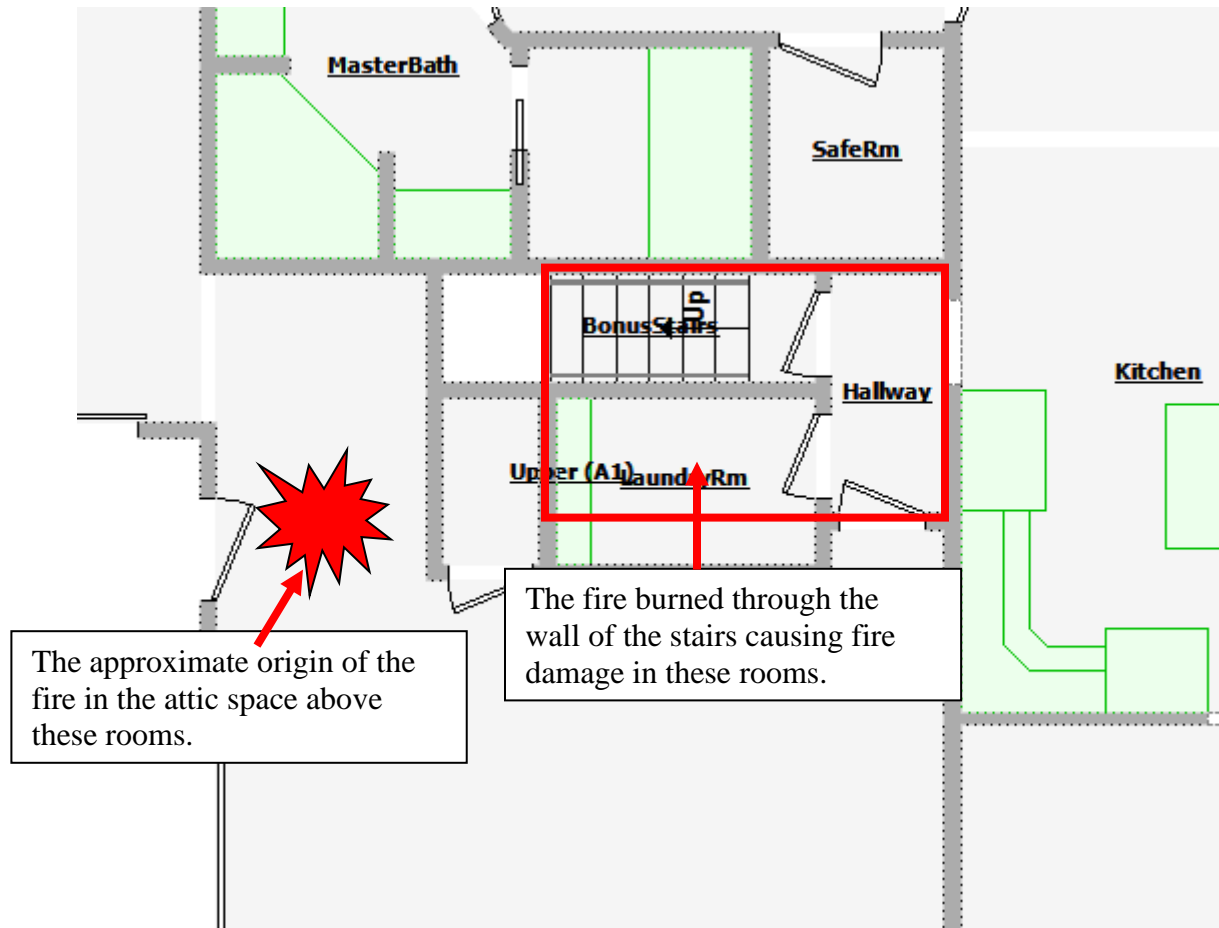
1. The fire had burned downward from the origin at the top of the stairs in the Bonus Room area. The fire damaged the finishes of the Garage Hallway and Laundry Room. Each of these rooms required the full replacement of the finishes including but not limited to: drywall, trim, cabinetry, floor tile, and light fixtures.

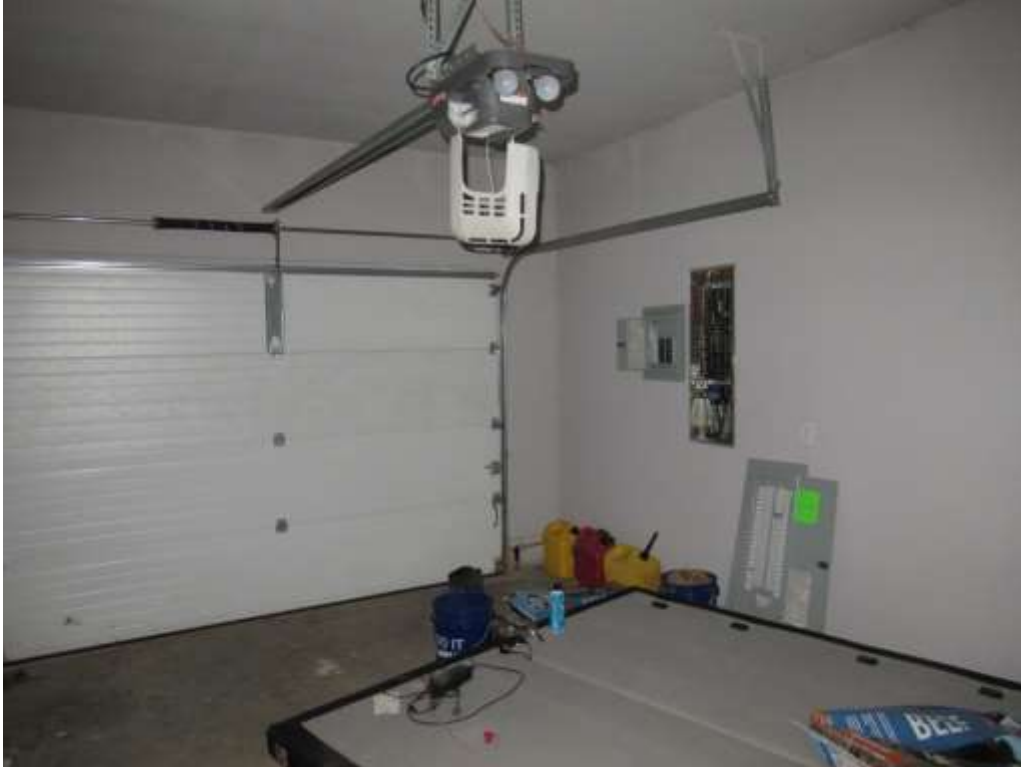
3. The finishes of the single-car garage suffered no visible fire damage. Smoke from the fire was present. However, framing above the south end of this room, in the attic space, was damaged by the fire.

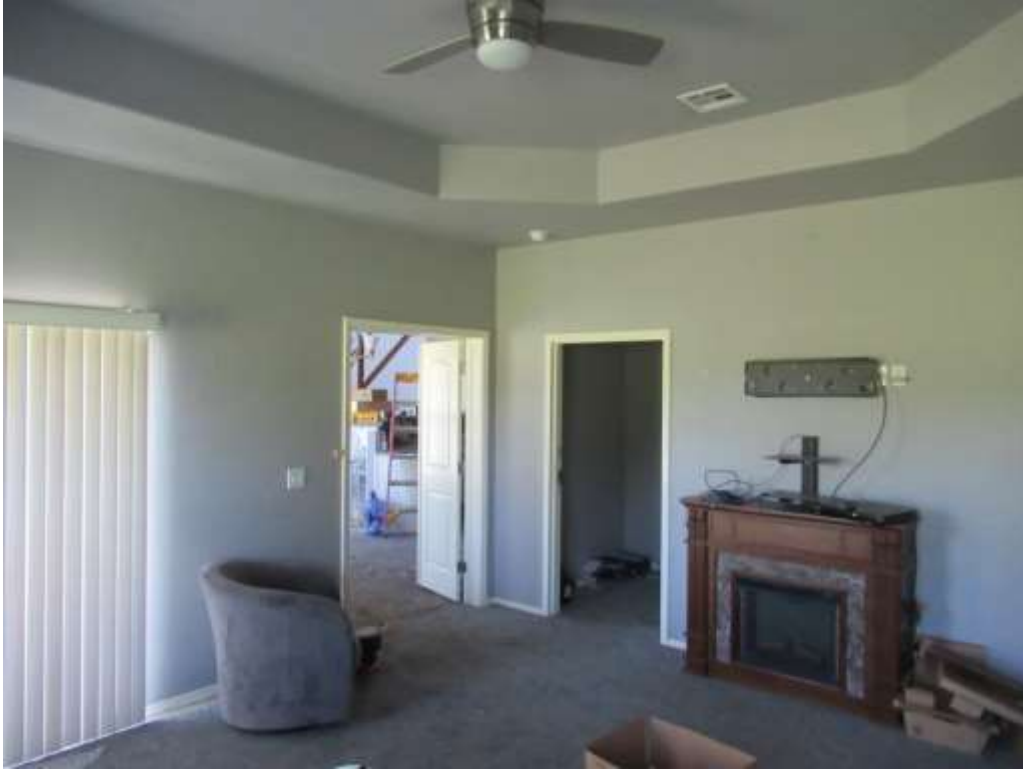
6. The remaining rooms including the Master Bedroom, Master Bathroom, Master Closets, Living Room, Powder Bath, Entry Closets, and Office all sustained soot/smoke damage. No fire damage was present. All finishes of these rooms can be remediated by cleaning and painting. The exception being the carpet and pad of the Master Bedroom and Closets. The tile floor covering ran continuously from the Garage Hallway and therefore replacement of this flooring was included in the proposed scope of work. The floor tile of the Master Bathroom and Guest Bath, as well as the white, cultured marble countertop of the Master Bathroom, were test cleaned. It was found these building components were cleanable and did not require replacement.

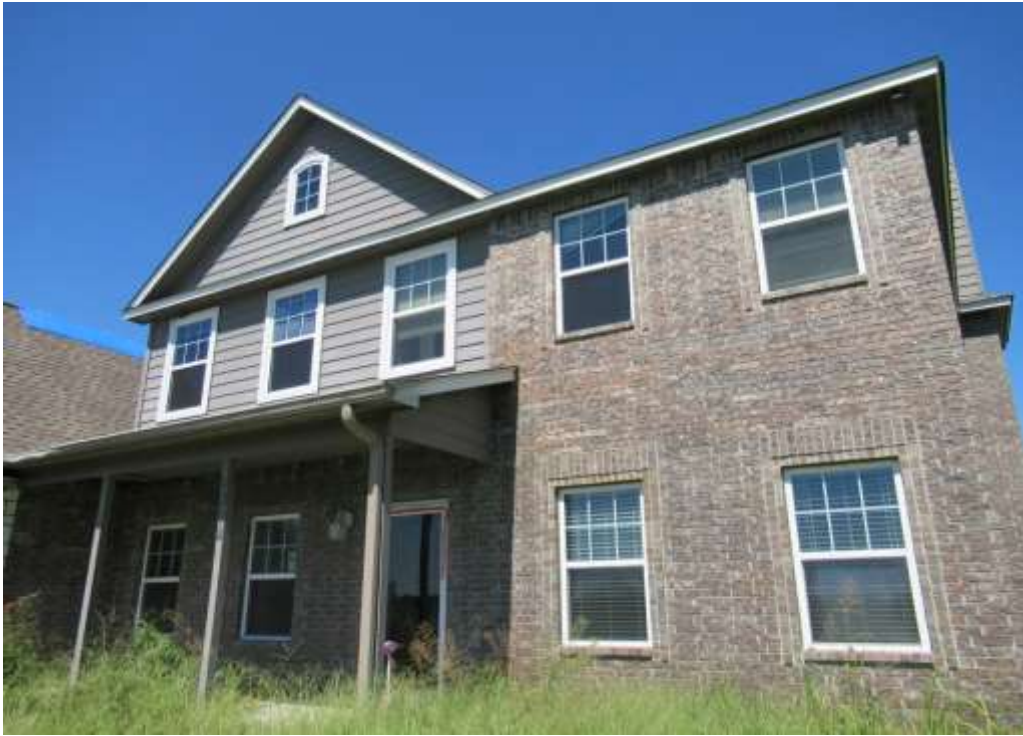
5. The gutter across the front of the porch appeared to have been damaged by the fire fighters accessing the roof. Otherwise, the remainder of the front elevation was undamaged.

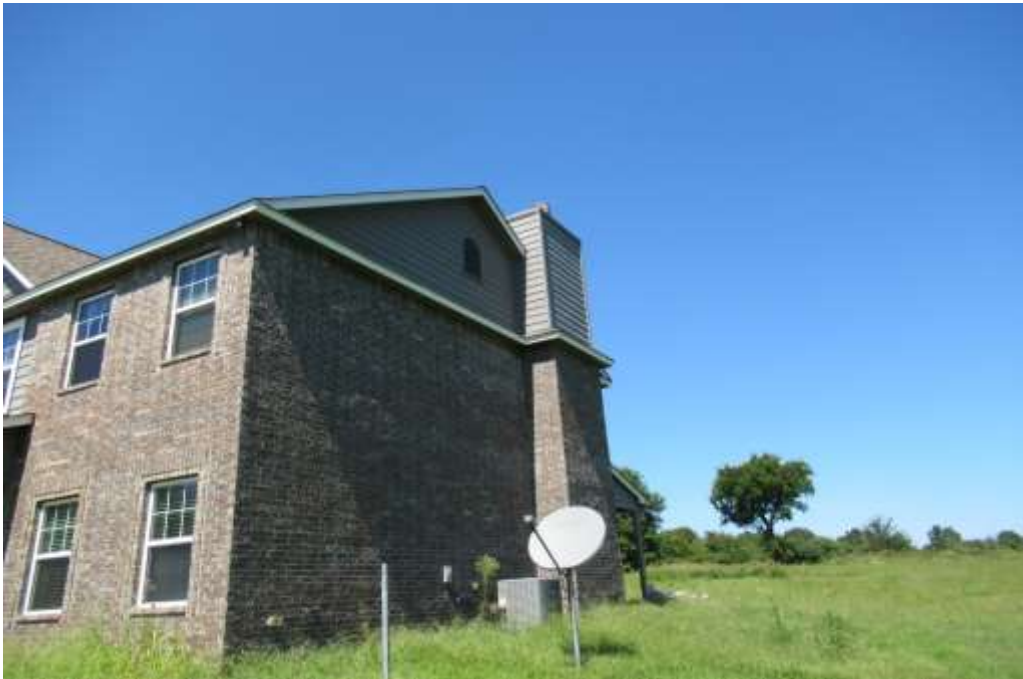
6. The east elevation of the residence was undamaged.

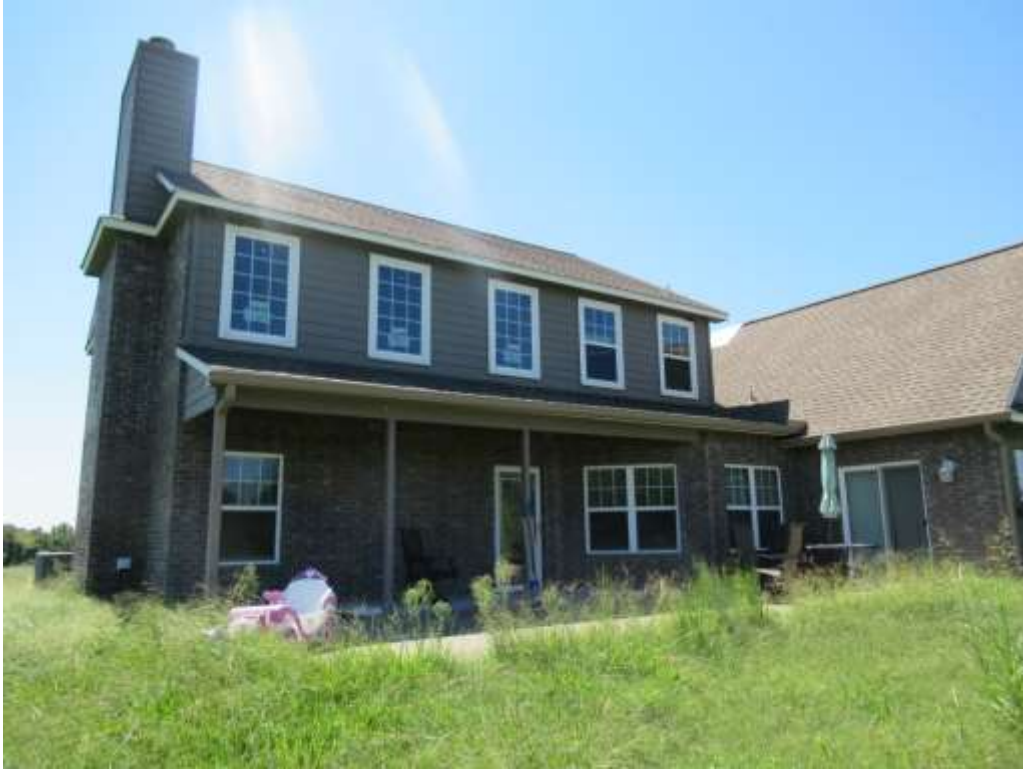
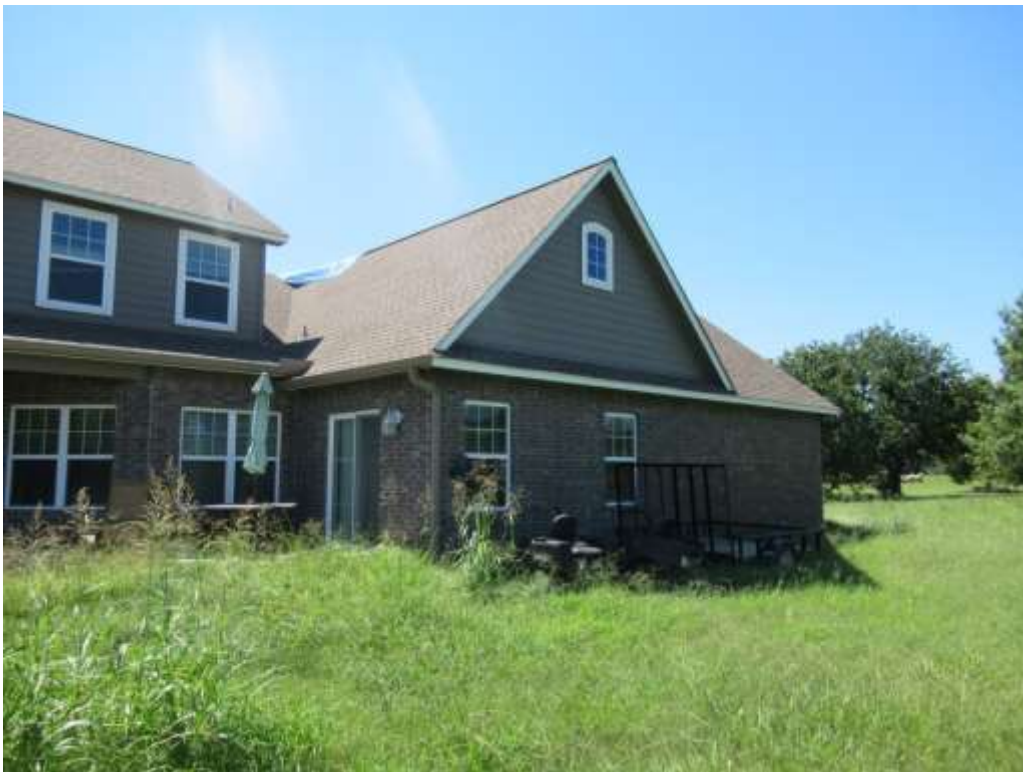
7. The back elevation was also undamaged.

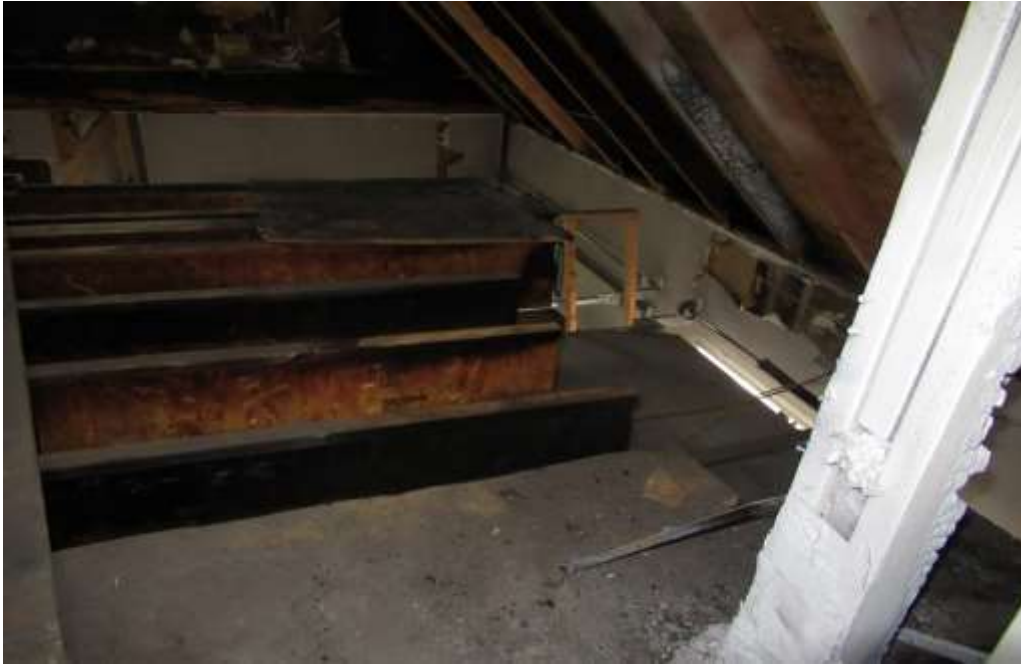
1. Much of the debris in the bonus room had been removed. The sagging floor I-beams had been cut back with a temporary wall placed below the remaining I-beams. The roof decking and some of the rafters had been replaced.

This photo is nearly the same perspective of that include at the top of page 11 of this report.

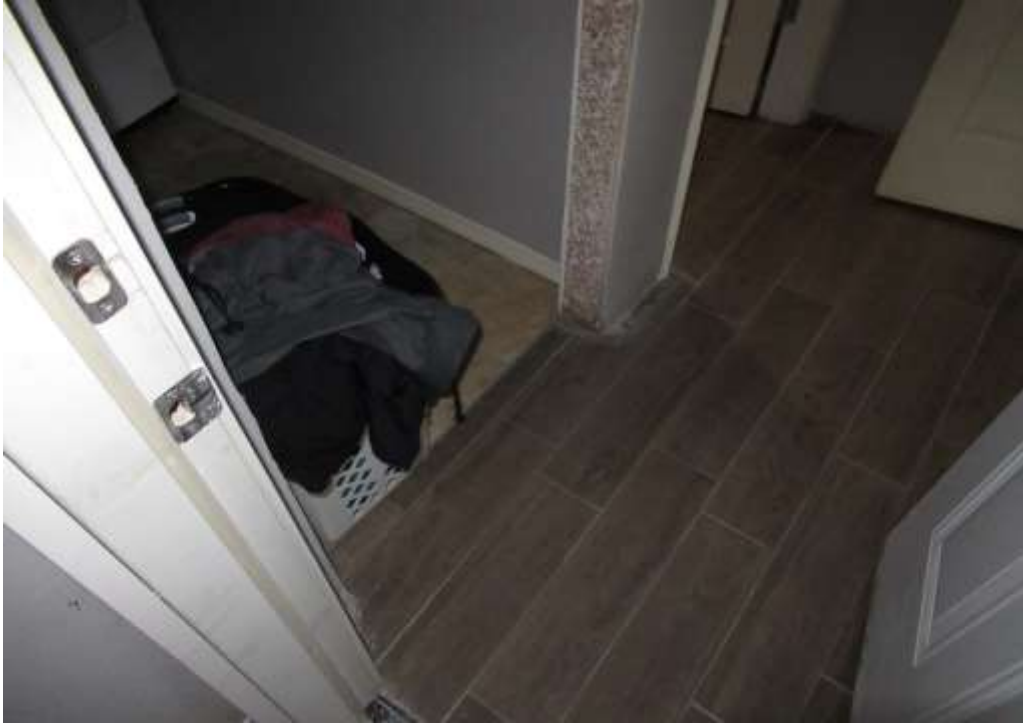
1. The fire damaged garage hallway had been partially repaired. New sheetrock, a new door to the Bonus Room Stairs, and a new door from the Garage had been installed. The room had not been painted and trim had not been installed. The flooring appeared to be the same and was not new.

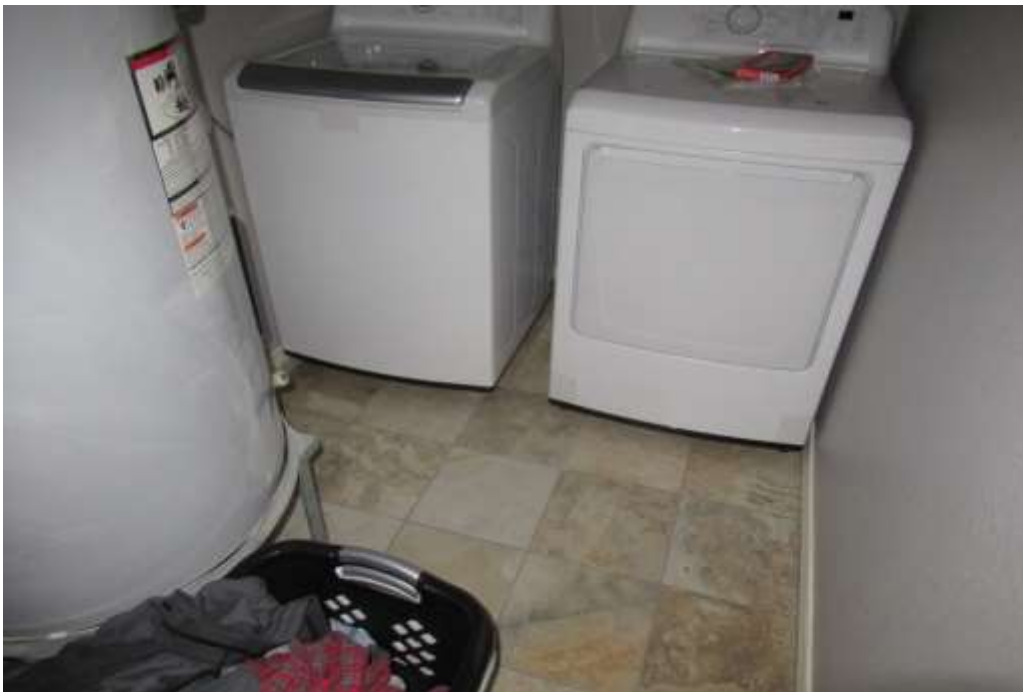
2. The Laundry Room was entirely finished indicating the finishes had not been replaced in this room. What appeared to be the original drywall, cabinets, baseboard, floor tile, and hot water heater were all still in place.

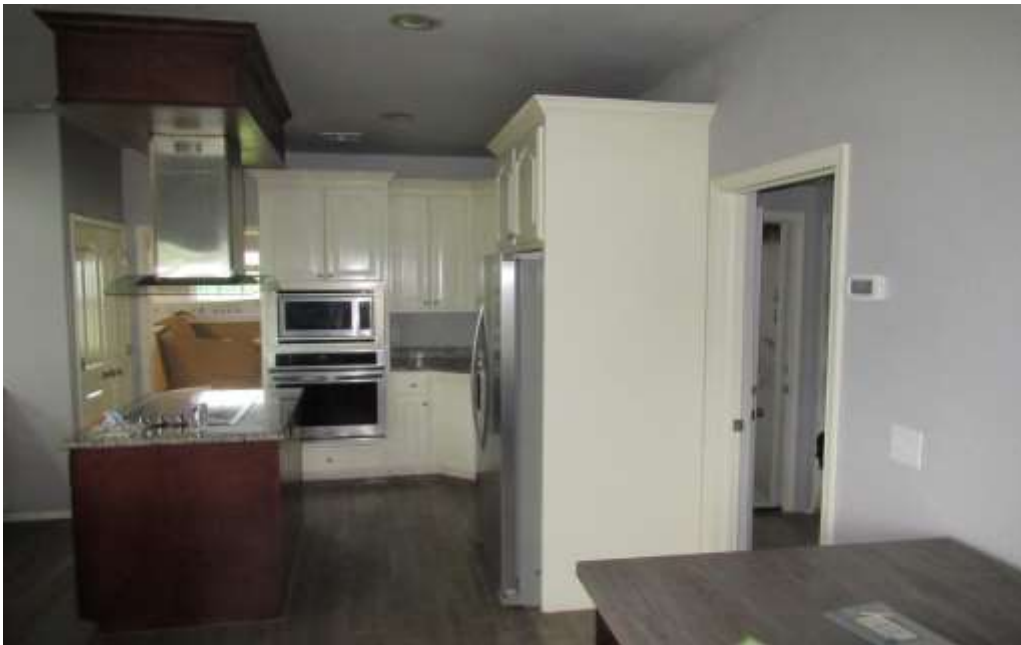
4. The fire damage to the Kitchen door casing, drywall, and cabinet bulkhead had been repaired/replaced and repainted. Kitchen fixtures had been cleaned but appeared to be the same units, including the appliances.

The kitchen from nearly the same perspective as that provided on page 20 of this report.
